Geräusch in der Autoklimaanlage: schon einmal an einem Problem mit dem Freilauf gedacht?

Noise in the A/C System:

have you ever thought of the freewheel pulley?

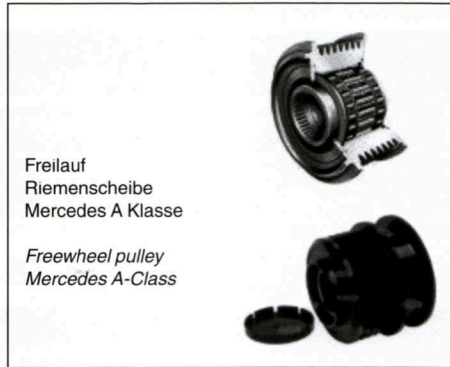
Wenn der Freilauf defekt geraten ist und festläuft, bedeutet dies in den meisten Fällen eine schlagartige Überlastung der schwachsten Komponente im Riemenkreislauf. Im täglichen Einsatz wurden festgelaufenen Freiläufen zur Folge bereits Kompressorriemenscheiben aus Gummi total losgerissen und Plastik Riemenscheiben zersplittert. Im Falle des bereits

erwähnten Volkswagen T5 ist es bereits vorgekommen, daß die Nabe des Kompressors beschädigt wurde.

If the freewheel fails and seizes, the weakest component of the belt circuit will take the immediate high intensity load blast which is the consequence of this seizure. In daily practice rubber compressor pulleys have already been found completely torn away from the compressor and plastic pulleys have broken into pieces, due to a seized freewheel pulley. In case of the already mentioned Volkswagen T5, compressor hubs have been seriously damaged after the freewheel pulley seized.
